## Case Study - Atlantic City Resort Casino Tests AerisGuard™ HVAC Performance Solutions Evaporator Coil Restoration & 3M Filters

# Case Study

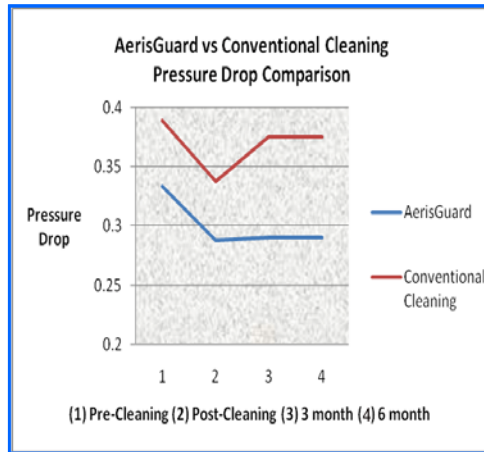
For Unit 1, there was an initial improvement in airflow of approximately 14% from 31,700 to 36,100 CFM. After two (2) months, the airflow began to decline and at the six (6) month timeframe the airflow returned to near pre-cleaning conditions of 32,786 CFM reflecting only a 3% improvement. The pressure drop across the coil prior to cleaning was recorded at .389 in WC and after an initial decrease similar to

airflow, the pressure drop at the six (6) month timeframe had returned to .375 in WC reflecting a 3.6% improvement.

Upon inspection, although the prefilters had been replaced at three months, it was found that the pressure differential across the prefilters had become great enough to cause collapse of the support cardboard causing the filters to pull through the rack and lodge against the box filters. The pressure drop across both filters was 1.3 inches WG. after 6 months.

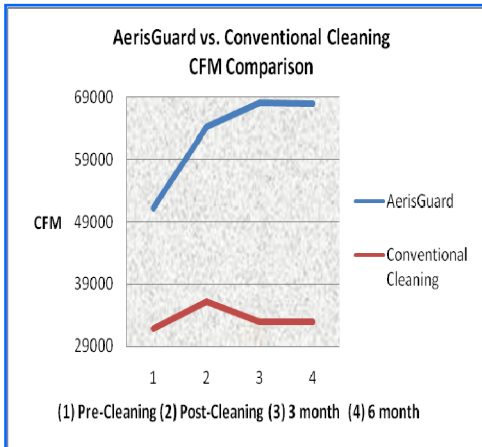
WC, an improvement of 13%. Additional data was collected on the AerisGuard restored units after eight (8) months that showed similar results, further indicating the coil has remained free of fouling.

Under the same operating conditions, every 3M filter was in place within the two inch rail structure and showed a pressure drop of only 0.44 inches WG. after 6 months.

For Unit 2, there was an initial 25% increase in airflow, from 51,200 to 64,200 CFM with additional improvement recorded at the six (6) month time frame of 68,093 CFM yielding an airflow increase of 33%. A similar improvement of pressure drop was recorded from 0.334 in. WC and after six (6) months the measured results were .29 in
